Response and recovery of the Eel River, California, and its tributaries to floods in 1955, 1964, and 1997

Jan Sloan^{a,*}, Jerry R. Miller^b, Nicholas Lancaster^c

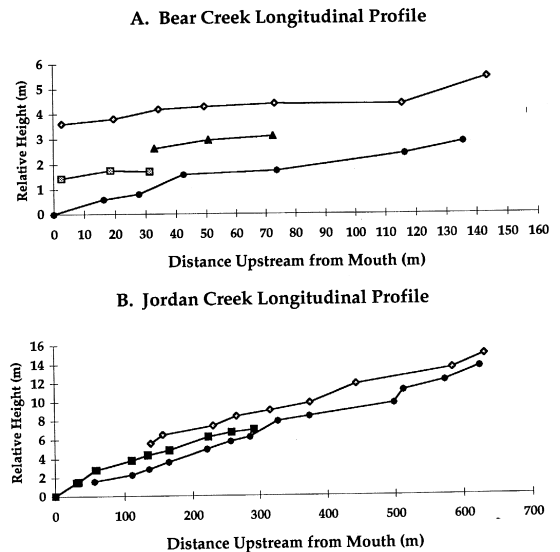
Fig. 5. Longitudinal profiles on Bear Creek (A) and Jordan Creek (B) measured in the summer of 1996. The surfaces delineated with closed circles represent the channel bed. Higher surfaces represent gravel terraces that tend to converge with the channel bed upstream.

paired across the valley floors (Fig. 9). Longitudinal profiles along the channel bed and selected terrace treads on Jordan and Bear Creeks show that the terrace surfaces converge and the number of terrace levels decreases upstream (Fig. 5).

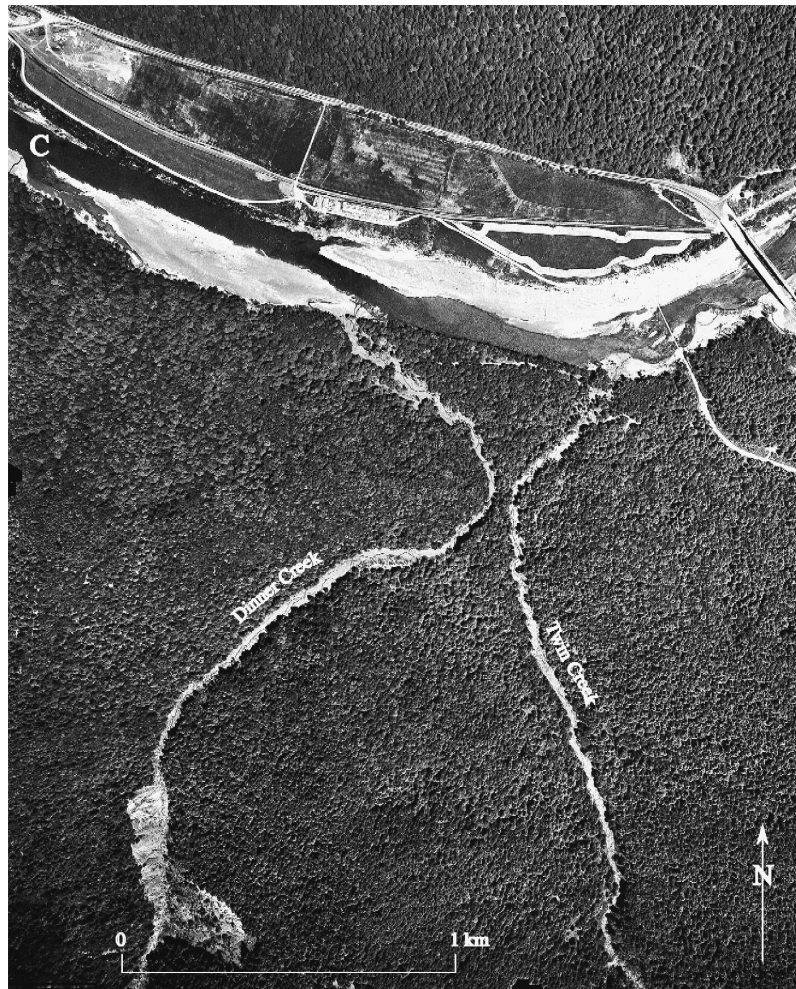
Fig. 7. (A) Dinner and Twin Creeks before the 1955 flood (1954 photograph). Riparian vegetation obscures the valley floors of both creeks. (B) Dinner and Twin Creeks after the 1955 flood (1960 photograph). Riparian vegetation has been removed and new gravel deposited along Dinner Creek. In contrast, Twin Creek appears to be unaffected by the 1955 flood. Hillslope failures were identified on the 1960 photos upstream in the Dinner Creek basin but not in Twin Creek basin. (C) Dinner and Twin Creeks after the 1964 flood (1966 photograph). Riparian vegetation has been removed and gravel deposits are visible in both Creeks. Hillslope failures were identified on the 1966 photos in both basins.

Fig. 7 (continued).

In contrast, Twin Creek appeared less affected by the 1955 flood (Fig. 7B). Four small hillslope failures totaling about 11,100 m² (about 0.2% of basin) were observed on 1960 photos at the headwaters of the Twin Creek basin. No changes in valley shape or

vegetation, however, could be detected on aerial photographs (Fig. 7B). The difference in response between Twin and Dinner Creeks to the 1955 flood may occur because of the size of the hillslope failures and the distance from the mouth of the creek. On Twin Creek, sediments may have been stored at the base of hillslopes as debris fans between the 1955 and 1964 floods.

In the 1966 photos, after the 1964 flood, vegetation had been removed from the lower reaches of Twin Creek and gravel deposited along the valley floor (Fig. 7C). Although 1966 aerial photographs only cover about half of the Twin Creek basin and 1974 photographs only covered about 90% of the basin, many small hillslope failures totaling about 13,500 m² were observed between 1.4 and 2.8 km

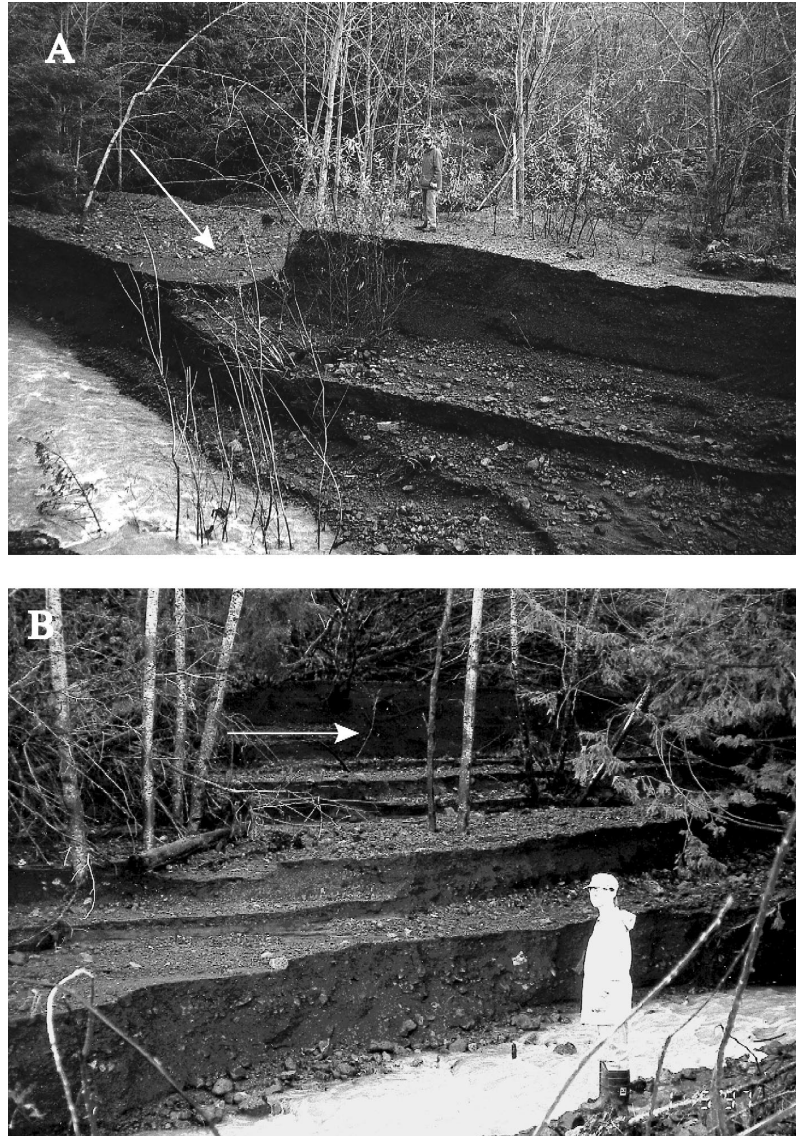
Fig. 8. New gravel deposits 4 days after the 1997 peak discharge on the Eel River. (A) At this location (about 0.2 km upstream of cross-section, Fig. 9B), at least five new terrace levels exist on Twin Creek, which are interpreted to have formed as the thalweg switched back and forth across the valley while incising into new gravel deposits. An abandoned channel (arrow) indicates that the creek flowed at a higher level and in a slightly different direction only a few days earlier. Lack of slackwater deposits indicates that the Eel River did not back up to this location. Trees that appear to be growing from the upper level are tops of trees covered by about 5 m of new sediment. (B) Kiler Creek (about 10 m downstream of cross-section, Fig. 9A), with five or six terrace levels in new gravel deposits. Slackwater deposits cap gravel in background (arrow).

buried by gravel deposits. Some trees were removed, and others were buried by gravel (Fig. 8). Some trees that were buried by 1997 gravel deposits were partially re-exposed by subsequent erosion within the same flood event.

Much of the material provided by hillslope failures appears to have been deposited in the lower reaches of the tributaries (Figs. 8 and 9). In 1996, gravel deposits with interbedded sand lenses were inset into much older Eel River terrace deposits and bedrock at the mouths of Twin and Bear Creeks. The sand lenses are interpreted to be slackwater deposits because they pinched out upstream and have a similar grain-size distribution as the slackwater sample collected on the terrace at Shively after the 1997 flood. The one or two sand lenses observed interbedded in gravel deposits in 1996 may be products of the 1955 and 1964 floods. Observations of similar slackwater deposits overlying gravel after the 1997 flood (Fig. 8) support the interpretation that these older lenses are slackwater sediments deposited during previous floods. Regardless of the time of deposition, the gravel and sand deposits demonstrate that extensive aggradation occurs within tributaries during floods.

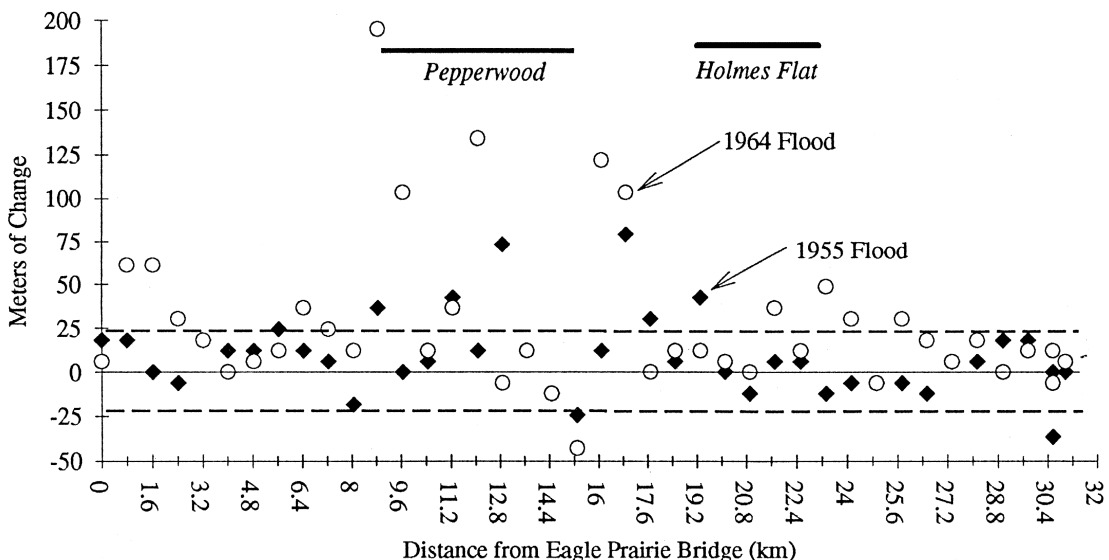
Fig. 10. Changes in channel widths between photo sets bracketing the 1955 and 1964 floods. Points above the zero line represent widening and points below the zero line represent narrowing. Changes in width between 24 and -24 m (dashed lines) were considered insignificant in this study (see Section 3). The dominant process of change during floods is channel widening. Most widening occurred by erosion of the Pepperwood terrace between 10.5 and 16.9 km upstream from Scotia.

With one exception, channel width after the 1955 flood had not returned to pre-flood conditions before the 1964 flood at sites that exhibited more than 25 m of channel change. Similarly, none of the sites that exhibited more than 25 m of channel widening during the 1964 flood had returned to pre-flood conditions by 1996, more than 30 years after the event.

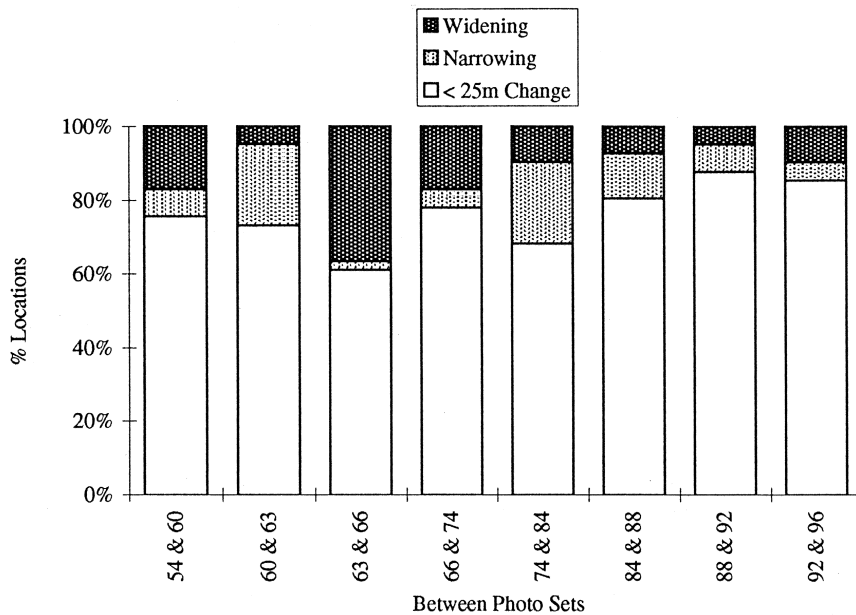
Fig. 11. Percent of locations (km markers) showing widening, narrowing, or less than 25 m of change in channel width between photo sets. Widening is more extensive than narrowing when comparing photographs bracketing the 1955 and 1964 floods, and narrowing is more extensive than widening in most of the comparisons between and after the floods, during the period of recovery.

The percentage of locations that indicate widening, narrowing, and less than 25 m of change document the relative importance of widening and narrowing during and after floods (Fig. 11). By considering only the type of change occurring at each marker, the magnitude of change was eliminated, which prevents a large measurement of widening from overshadowing a smaller measurement of narrowing. Based on comparison of the type of change for each set of photos, widening is dominant when comparing photo sets that bracket the 1955 and 1964 floods and narrowing is generally dominant when comparing photo sets between and after floods (Fig. 11).
